# Belvidere Theatre

129 Nevada Street  
Central City, Colorado 80427

Historic Structure Assessment and  
Preservation Plan  
SHF Grant No. 2016-HA-005  
Deliverable #5 Final HSA  
July 2016

**HISTORIC STRUCTURE ASSESSMENT  
AND  
PRESERVATION PLAN**

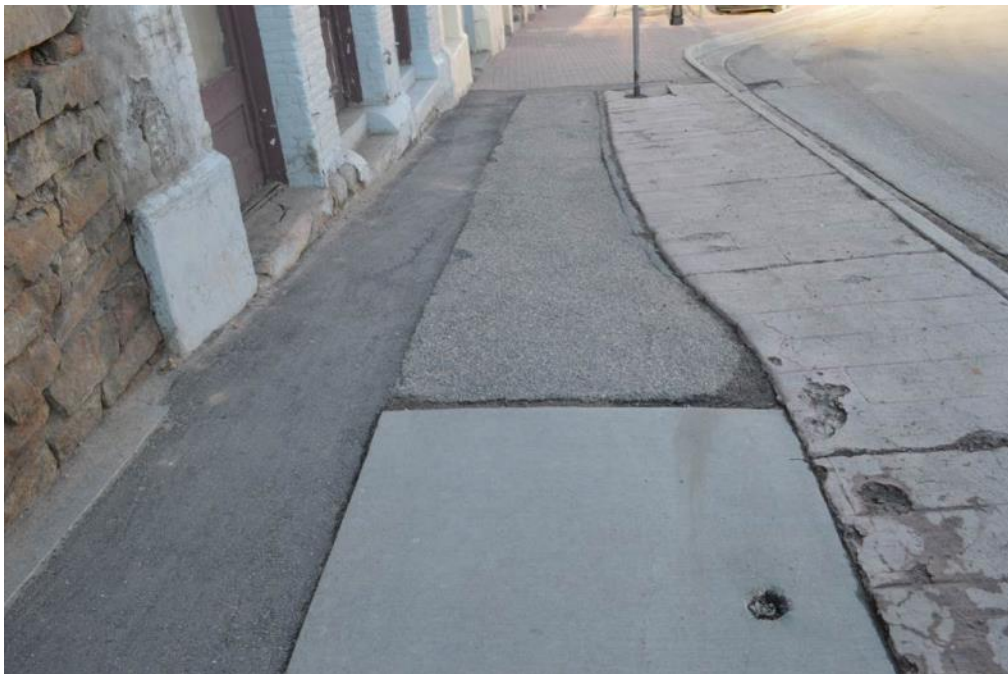
The site to the east of the building is in fair to poor condition. The concrete pavement along the curb is in poor condition with several areas of cracking and spalling (*Re: Figure 17*). Where the asphalt and concrete meet, the joints are separating. The joint between the pavement and the building is open in several sections along this elevation.

*Figure 17: Detail view of various pavement types to the east of the theatre building.*

- Coat areas of rust with rust-converting primer
  - Prep, prime, and paint
- Seal building to pavement joints along the east and west elevations. (Critical)

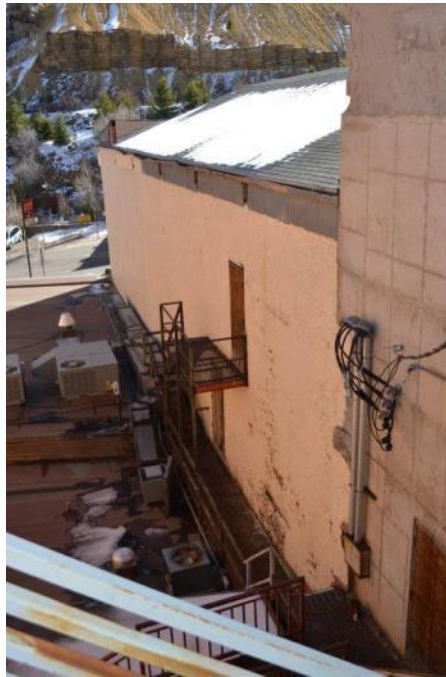
To the north, the theatre is immediately adjacent to the neighboring building. The fire escape mounted to the north wall of the theatre is in fair condition. The metal components are exhibiting rust and deterioration (*Re: Figure 18*).

*Figure 18: North elevation of the theatre. Note the fire escape mounted on the north wall of the theatre.*

- Rehabilitate metal fire escape to the north of the theatre. (Serious) Rehabilitation should include:
  - Remove loose material
  - Replace missing and severely damaged metal components

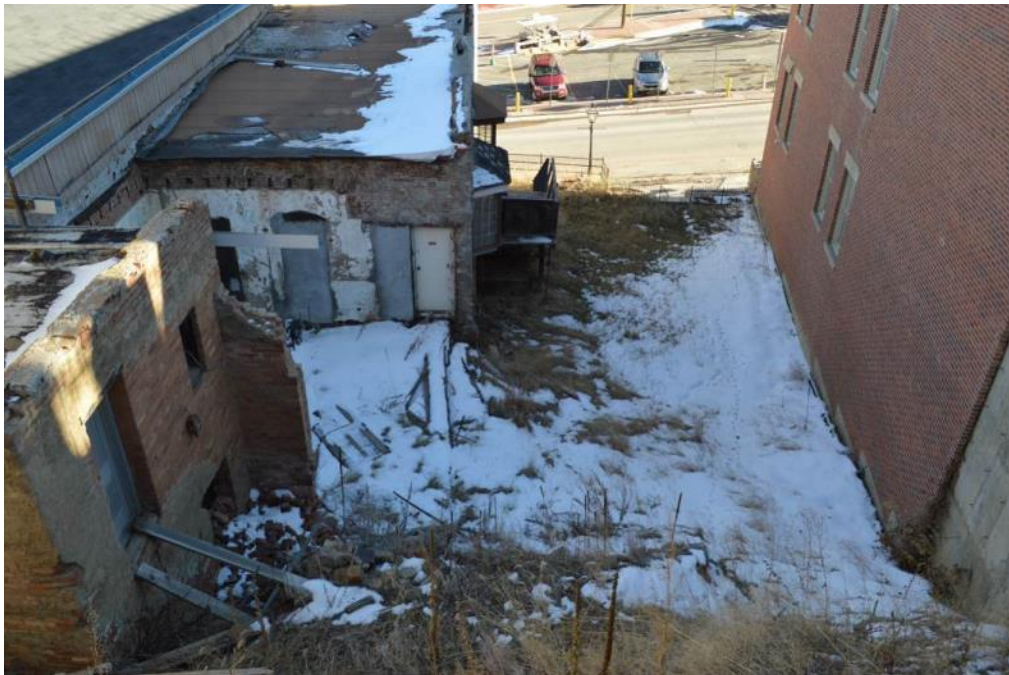
*Figure 21: Overall view of the site to the south of the building. Note construction debris near the building in the lower left corner of the photo.*

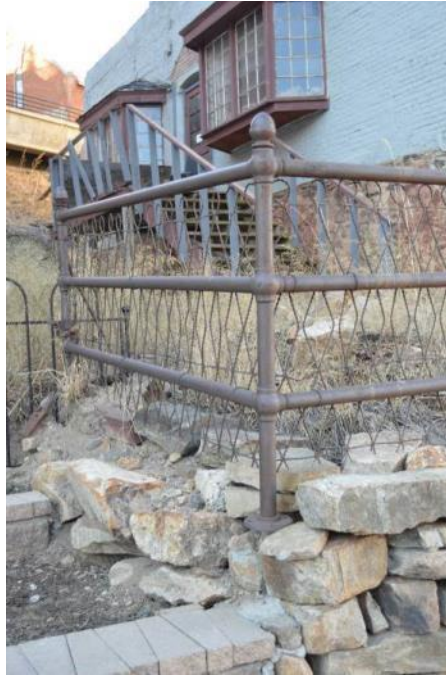
*Figure 22: Detail view of fence atop the masonry retaining wall extending south from the southeast corner of the building.*

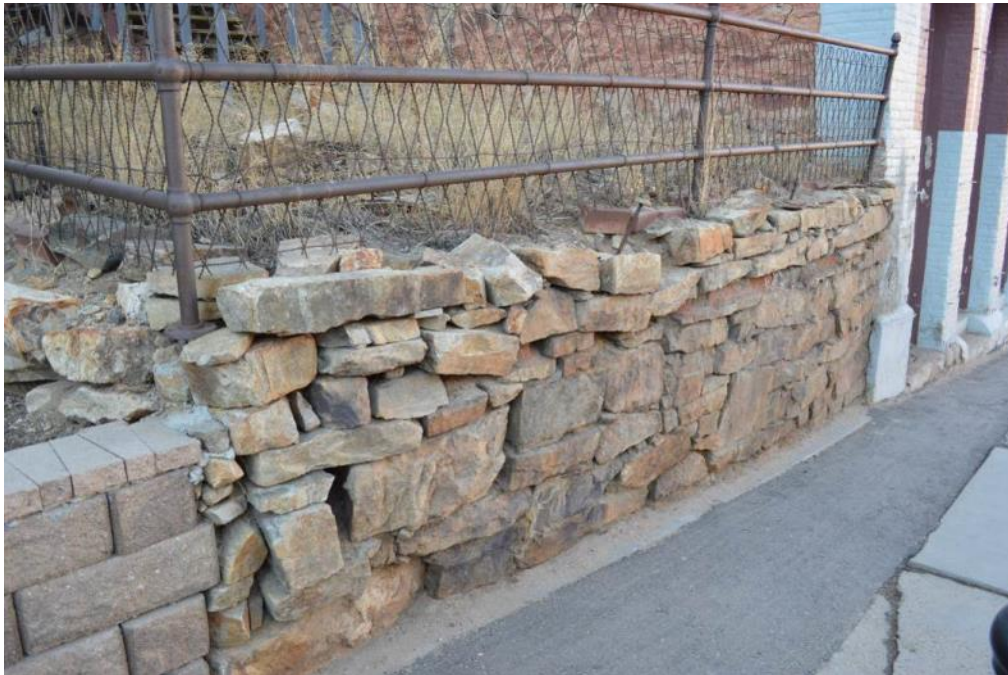
The site to the south of the building is in fair condition. The site is overgrown, primarily with native vegetation. The site wall along the sidewalk extending south from the southeast corner of the building is in poor condition. The wall is bulging out and out-of-plane movement is notable. The fence atop the wall is leaning outward, which is a result of the deterioration of the masonry wall. The CMU walls and stairs along the east side of the courtyard are in good condition.

*Figure 26: Overall view of retaining wall to the southeast of the building. Note out-of-plane movement and bulging in the wall.*

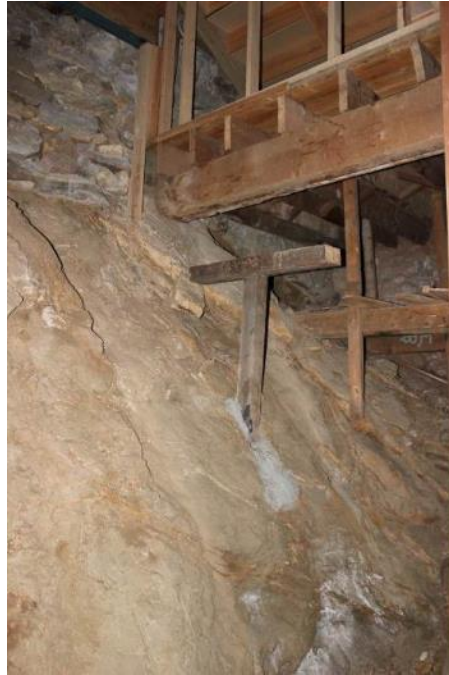
The perimeter foundations for the load bearing stone masonry walls of the Shoo Fly portion of the building are not exposed (*Re: Figure 29*). They are presumed to be a below-grade continuation of the stone ashlar walls as a stem wall. The stem foundation wall may bear upon a wider rubble stone footing or they may bear directly upon the sloped stone ledge (bedrock) present at the site. The stone ledge is visible in the pit area below the stage floor framing (*Re: Figure 30*).

*Figure 30: Stone ledge under the pit portion of the building*

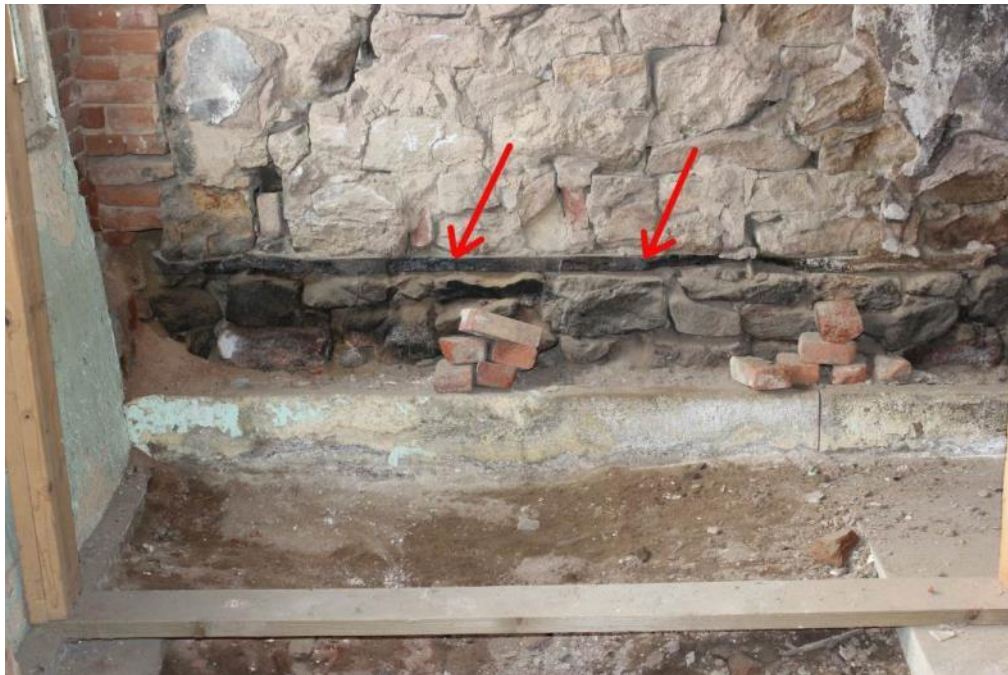
There is a 2 inch thick wood board or nailer located in the walls approximately 2 stone courses above grade (*Re: Figure 31*). For the purpose of this report discussion we have defined the foundation wall as the portion of the wall below the wooden plate. The portions of the wall above the plate are designated as walls for discussion and are discussed in the exterior wall section of the report.

*Figure 31: 2 inch thick wood plate embedded in the base of the masonry walls of the Shoo Fly*

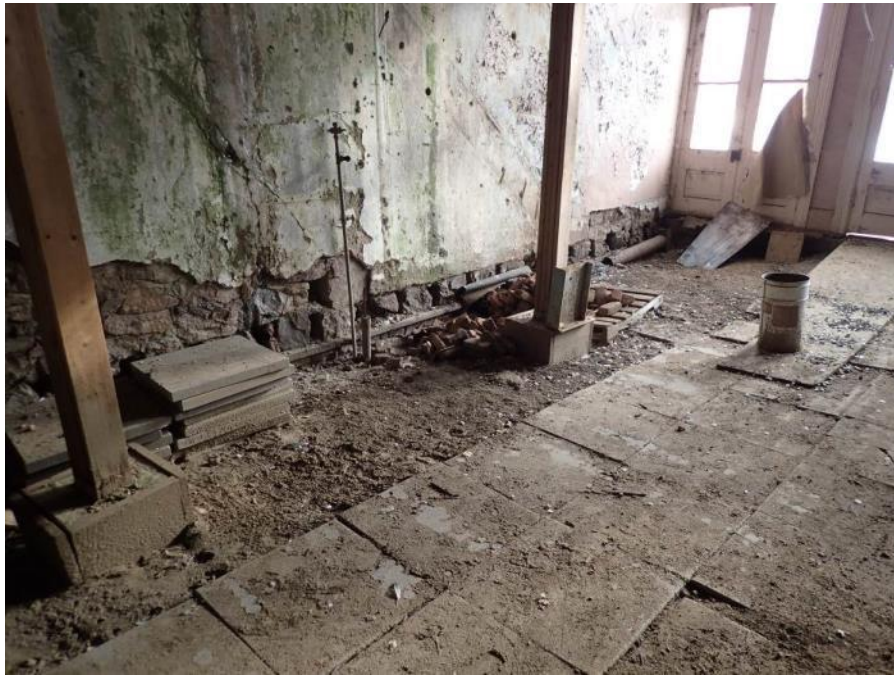
New wood posts introduced into the Shoo Fly first floor during the abandoned casino renovation have concrete spread footings that bear upon the exposed earth floor (*Re: Figure 32*). These modern footings are presumed to have a minimum amount of steel reinforcing bars present, but this should be verified if these footings are to be retained in the rehabilitation. The height of the new concrete footings appears to generally match the beam pockets in the stone walls for the now removed elevated wood first floor.

*Figure 32: Added wood posts in the Shoo Fly at the lower level on concrete footings*

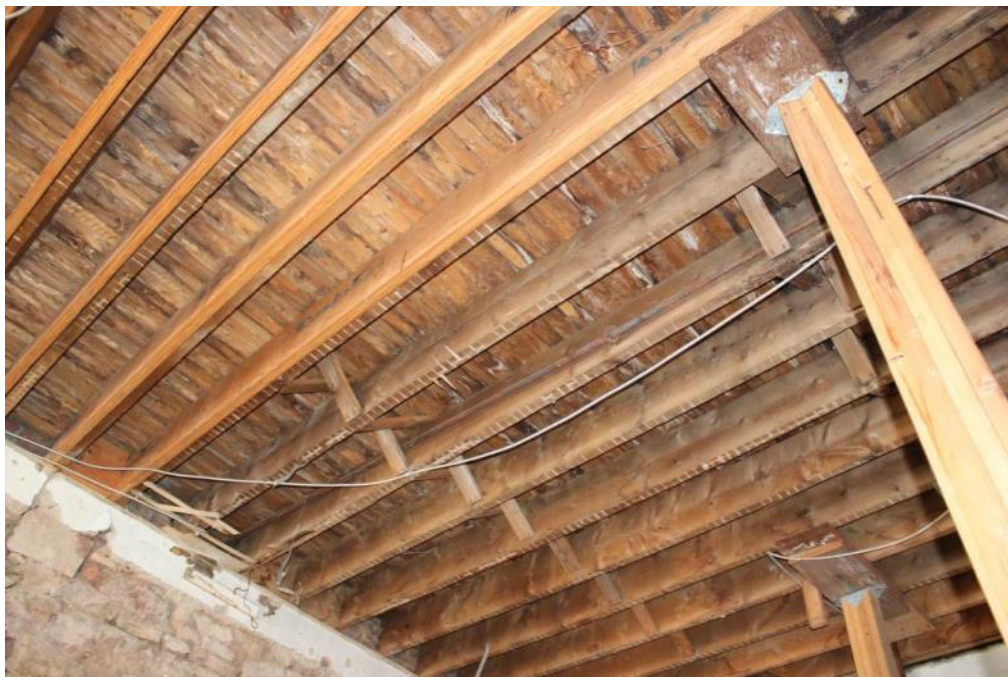
*Figure 38: Upper level floor framing of the Shoo Fly. Note the x-bridging, the sistered members to the left of the image, and the lath markings on the bottom face of the joists*

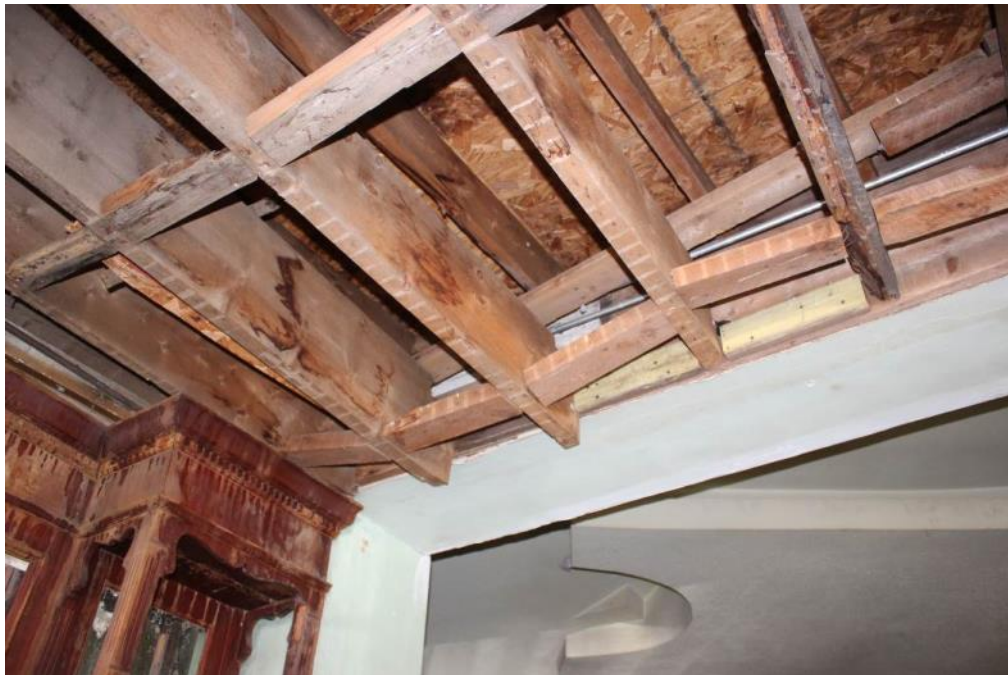
At the northwest corner of the Bar in the Shoo Fly, the ceiling joists are slipping off of the steel angle ledger (*Re: Figure 40*). This is a result of the north wall of the Shoo Fly leaning towards the north.

*Figure 40: Ceiling joists of the Shoo Fly bear on a steel angle attached to the concrete framed openings between the bar and the theater*

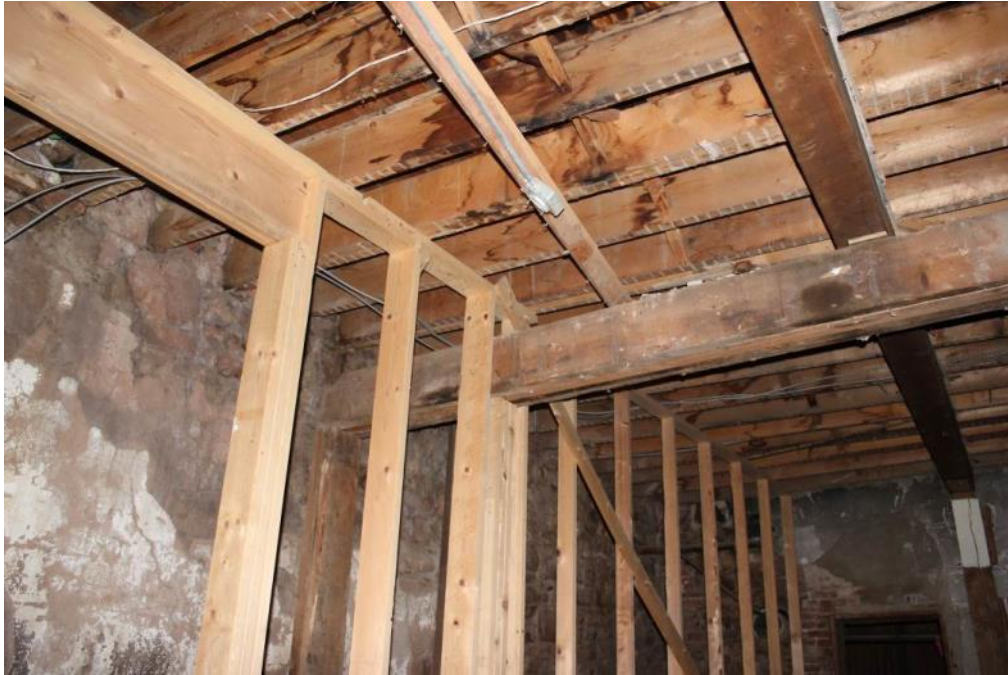
*Figure 43: Supplemental bearing line installed in the late 20th century just north of the wall between Room 01 and Room 02. This bearing line must remain in place until all work on the floor and walls is completed*

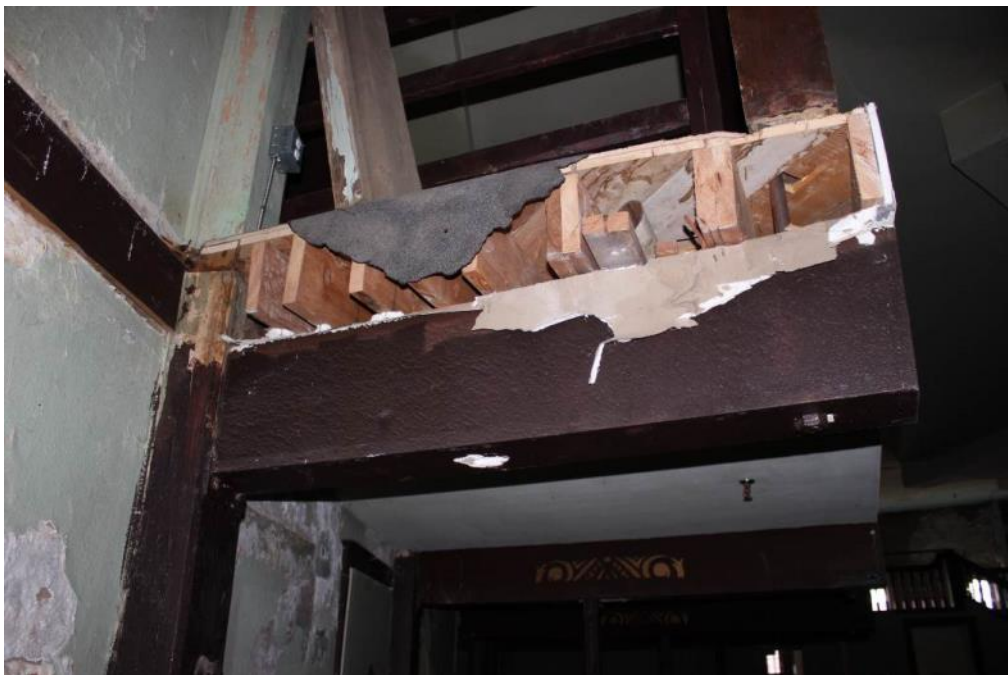
*Figure 44: The mezzanine of the Theatre is framed with 2x8 joists supported on wrapped six-ply beams*

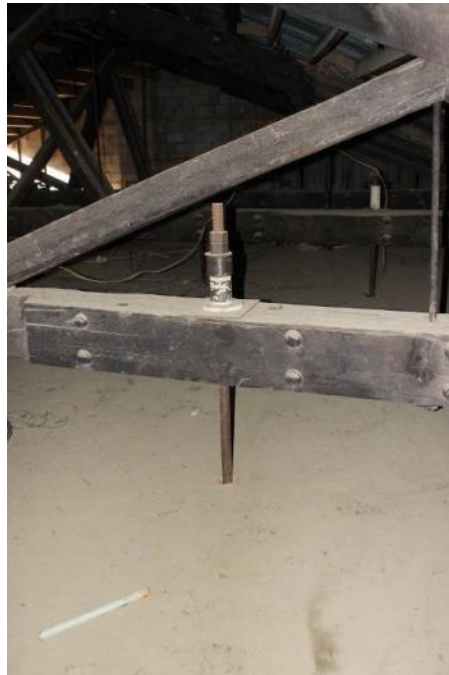
*Figure 45: Mezzanine floor is hung from the roof timber trusses with 1 3/4 inch diameter rods*

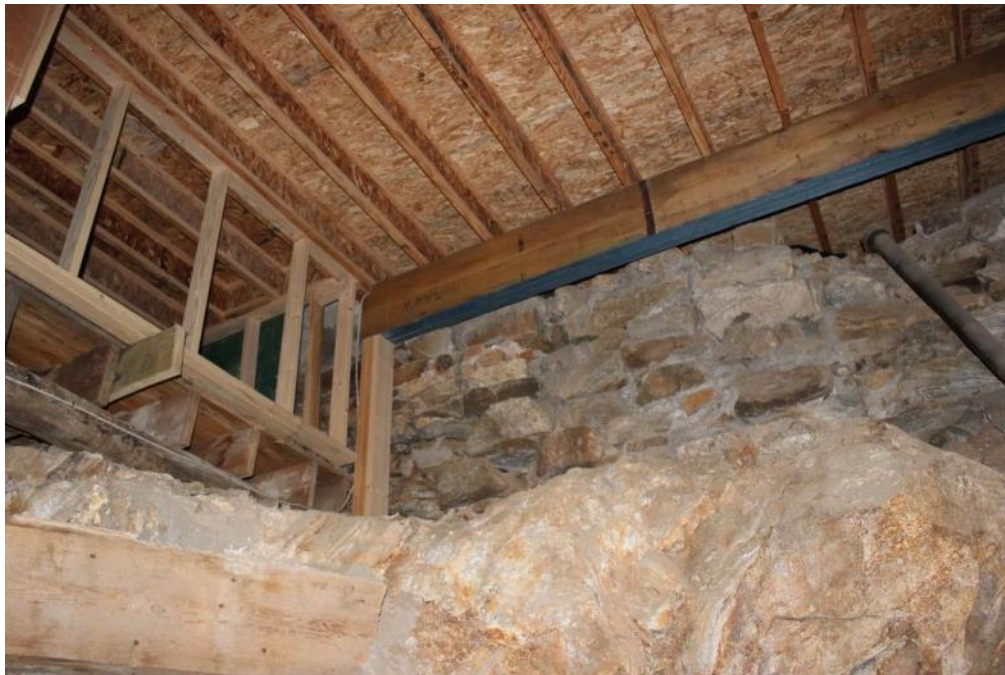
*Figure 46: Triple-ply laminated veneer lumber beam supporting the stage framing*

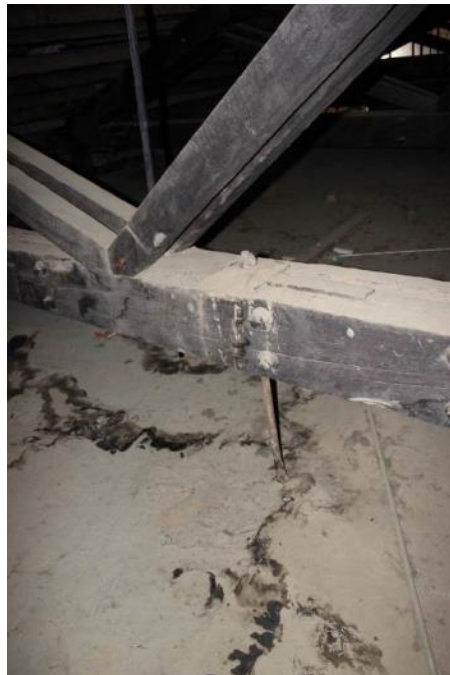
*Figure 50: The original roof rafters are hung from 7/8 inch diameter rods that are attached to the timber roof trusses of the Theatre*

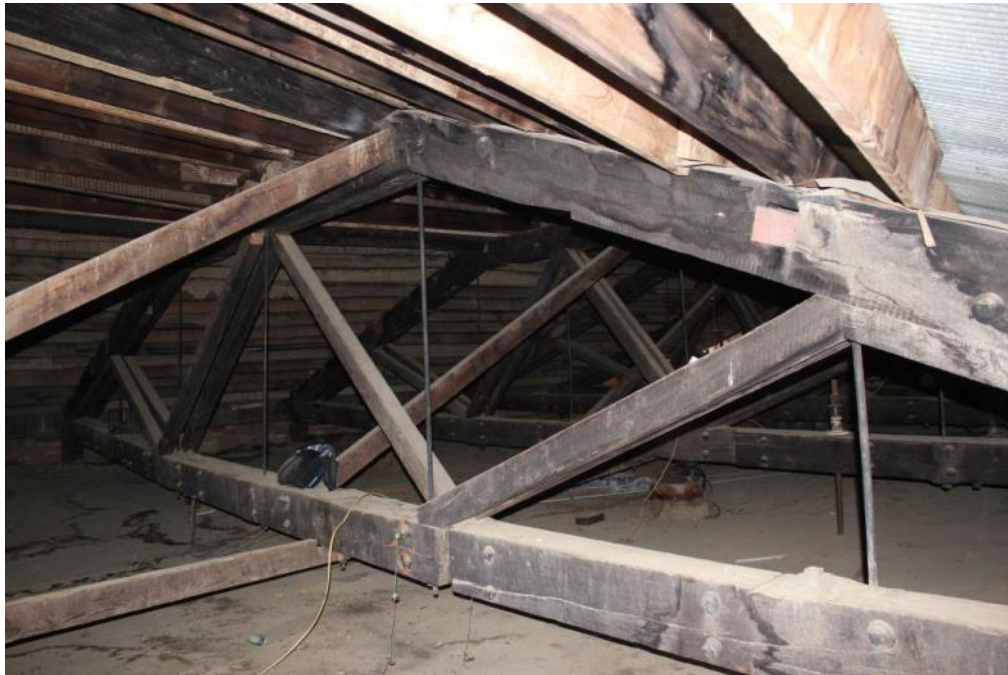
*Figure 51: The timber roof trusses of the Theatre. Note the diagonal bracing between the trusses as well as the horizontal bracing at the bottom chord*

- Confirm how the original Theatre roof is framed and how it is currently supported by the roof trusses. Following investigation of theatre roof framing, perform structural analysis of roof trusses and develop repair details for roof trusses. Rehabilitate the trusses as required. (Critical)

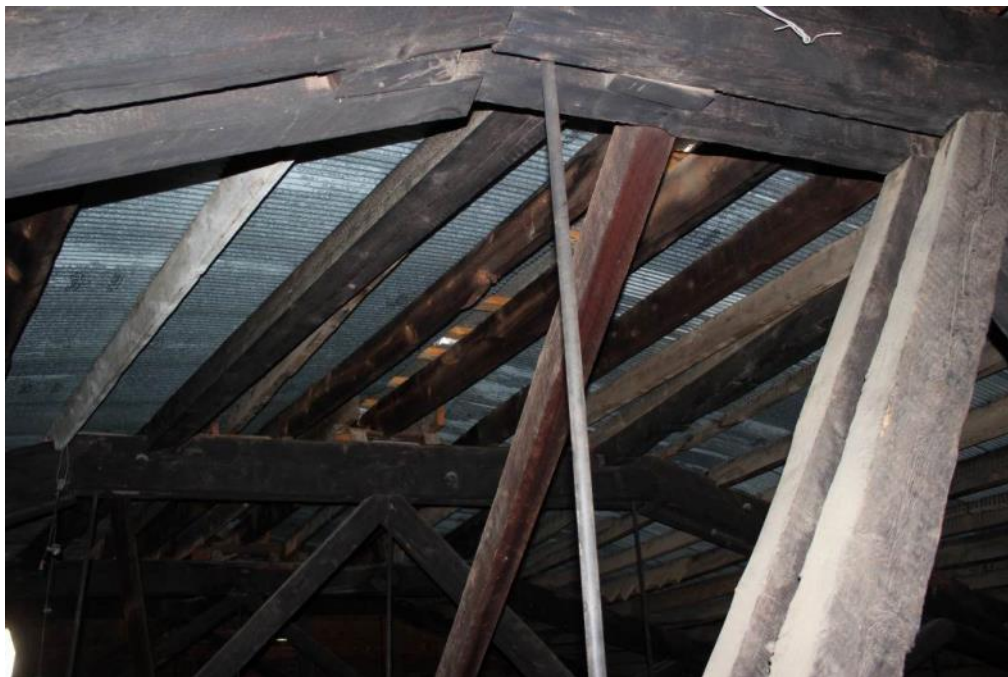
*Figure 52: Large timber girders span between the top chords of the timber roof trusses of the Theatre. Note the 2x8 roof rafters and metal roofing material*

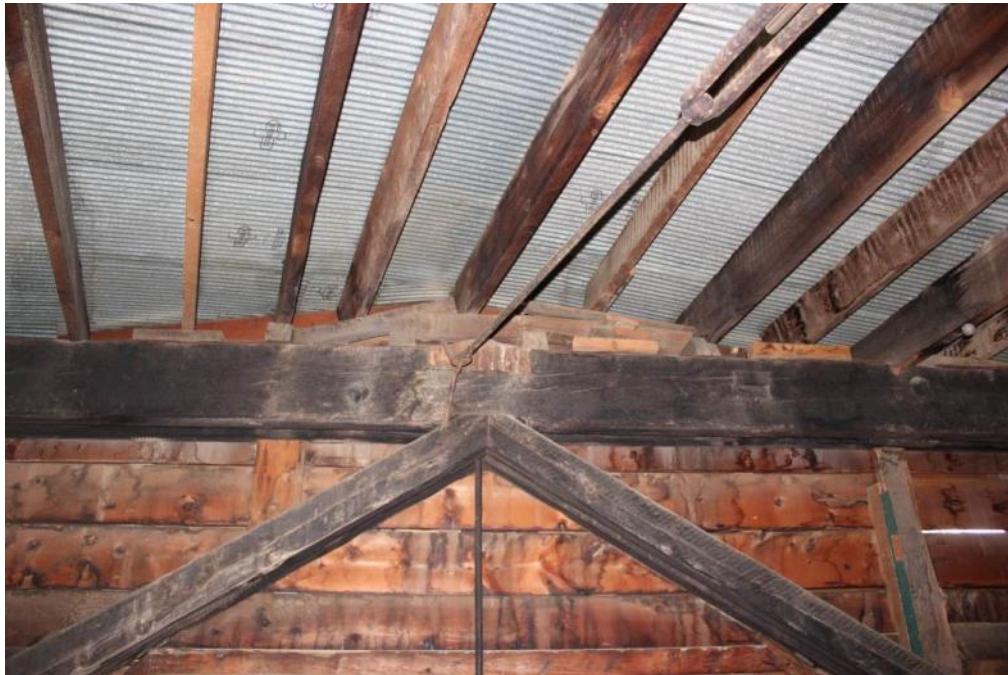
*Figure 53: Between the two easternmost timber roof trusses over the Theatre, a 3/4 inch diameter rod spans between the top chords*

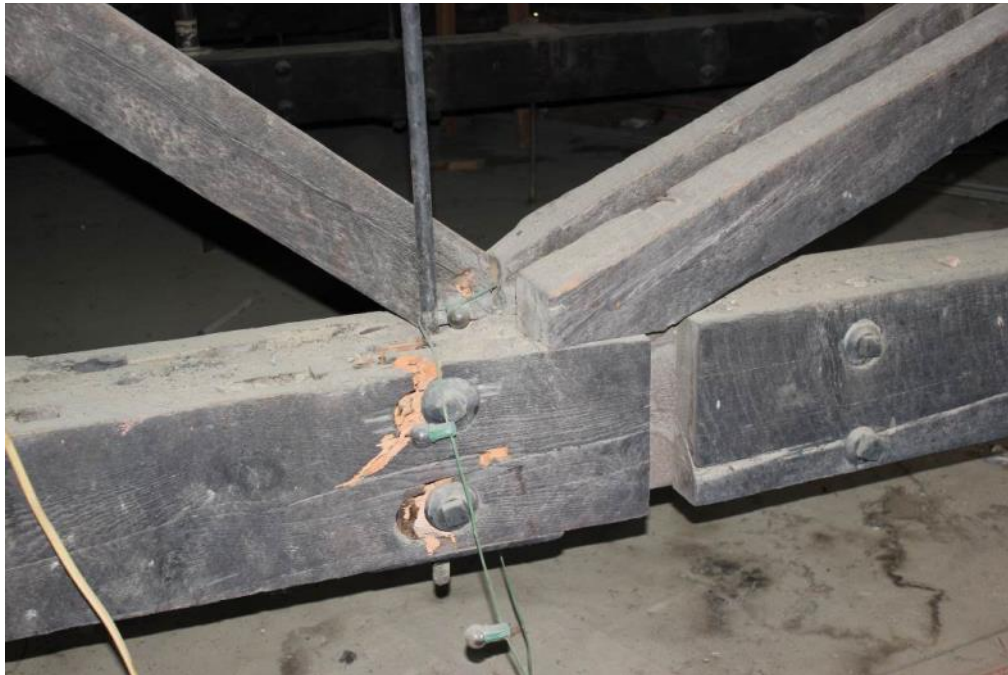
The original roof framing of the Theatre is in good condition, but the roof trusses above are in poor condition. The top chord of the second truss from the east has rotated to the east. In this same truss, the bottom chord has broken where the inner members of the chord began to rot and one of the diagonal struts has fallen out of place (*Re: Figure 55*). At the southern bearing point of the third truss from the east, the brick bearing has been removed (*Re: Figure 56*).

*Figure 55: The bottom chord has split in the second timber roof truss from the east over the Theatre*

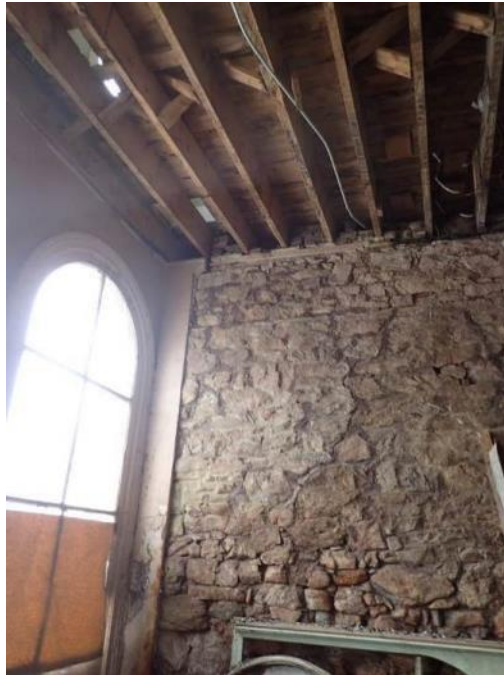
*Figure 57: In the Shoo Fly, the coursing of the masonry shifts from rubble ashlar stones with random coursing for the bottom of the wall to uniform coursed square cut stone for the upper two feet of the wall*

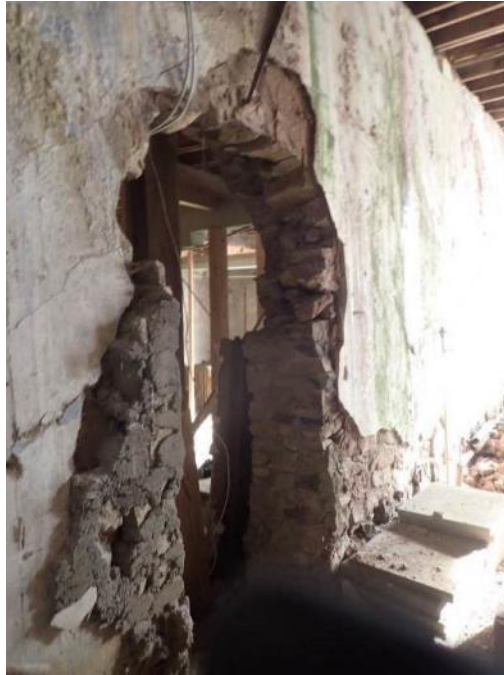
The north wall of the Shoo Fly was incorporated into the Theatre during the construction of the adjacent structure and is now an interior wall of the theater space. A rough arched opening was made in the north wall at the lower level providing access between Room 01 and Room 02 (*Re: Figure 58*). The stone ashlar is approximately 18 inches thick at this location. The wall has two leaves of coursed face stone with an interior rubble fill of smaller stones. Larger stones protrude into the inner core tying the faces together (*Re: Figure 59*). However, thru-stones were not observed to tie the entire wall thickness together. Without thru-stones, the tie between the faces of the wall is tenuous at best. The remainder of the first floor stone walls are likely the same thickness and construction.

*Figure 58: Rough arched opening made in the north wall of the lower level between Room 01 and Room 02*

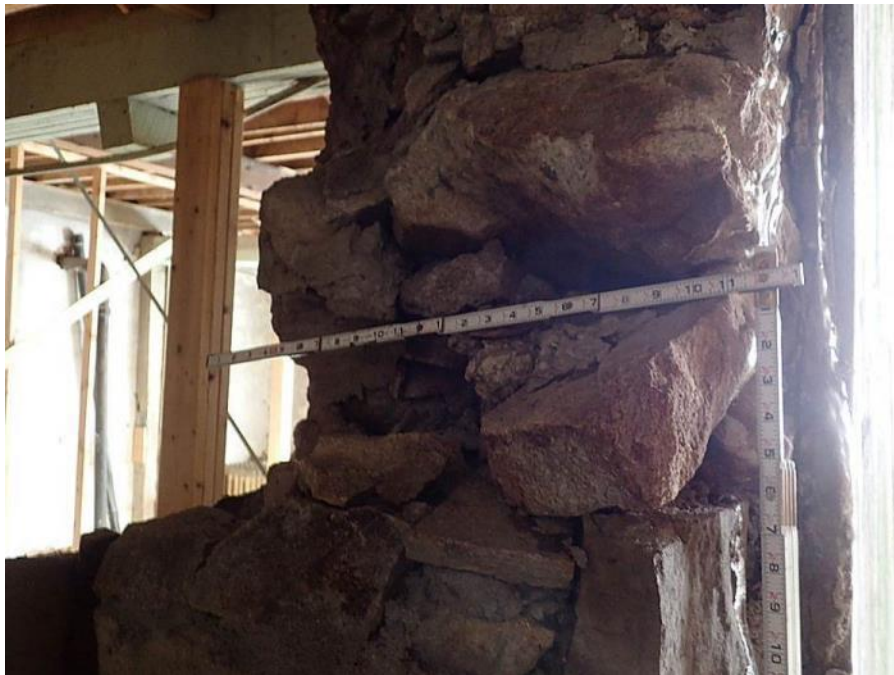
*Figure 59: Some larger stones protrude into the core of the wall tying the faces together*

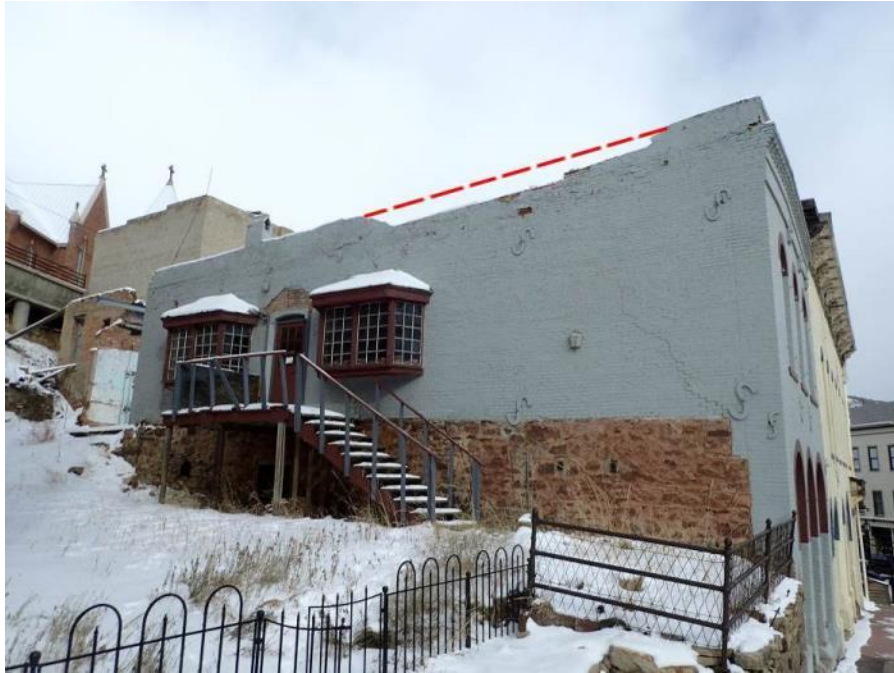
Portions of the south parapet wall have been removed to the roof line (*Re: Figure 60*). It appears the bricks from the parapet have been salvaged and are stored inside the building at the bay window (*Re: Figure 61*). There are currently two bay windows and a door opening in the south wall. The windows are not original but appear to be enlarged openings at former door locations. The door between the bay windows is not original. The date of installation of the bay windows and the door is unknown. The side brick walls are constructed with common bond and having tie courses of header bricks every seventh course (*Re: Figure 60*).

The component brick and mortar comprising the parapets are in poor condition. Portions of the south parapet have been removed. Presumably this was done to mitigate the potential falling hazard.

*Figure 60: Some portions of the parapet of the south wall of the Shoo Fly have been removed down to the roof line*

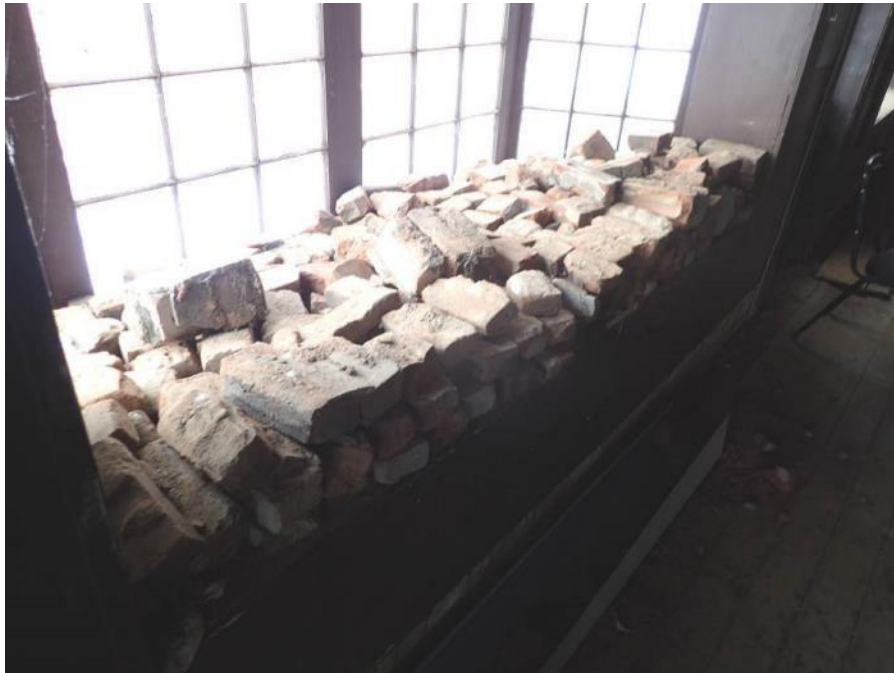
*Figure 61: Salvaged brick from the south parapet of the Shoo Fly stored in the bay window of the same wall*

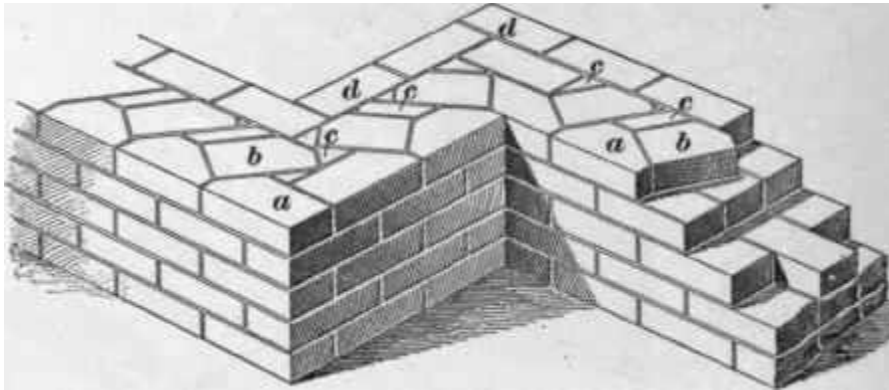
The front façade (east elevation) does not have any visible header brick coursing. It is possible that the front façade has concealed diagonal headers (*Re: Figure 62*). It is unlikely that a building from this era would have metal ties between the face wythe and backup brick.

*Figure 62: Diagram of concealed diagonal headers in a brick masonry wall (image from “The Art of Bricklaying”). This condition may be present at the exterior masonry walls, but should be confirmed.*

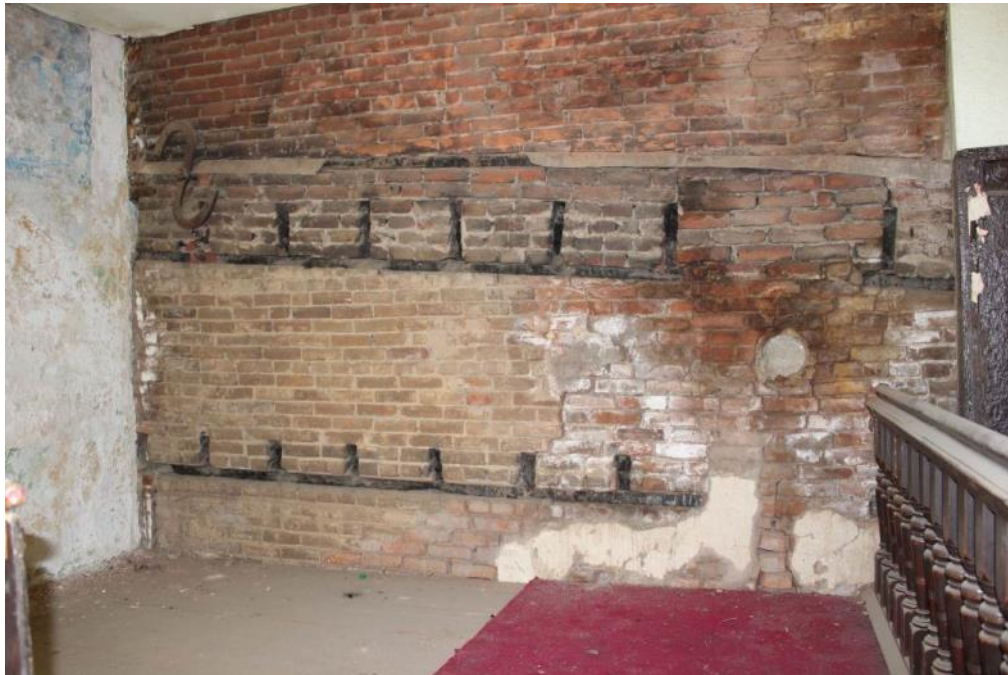
Remnants of burned wood roof framing from an earlier structure are visible in the north face of the second floor north wall. The fire does not appear to have compromised the brick at this location. The remaining charred wood elements do not compromise the overall structural capacity of the wall at this location (*Re: Figure 64*).

*Figure 64: Joist pockets and charred remains of an earlier structure in the same location that the Theatre currently occupies*

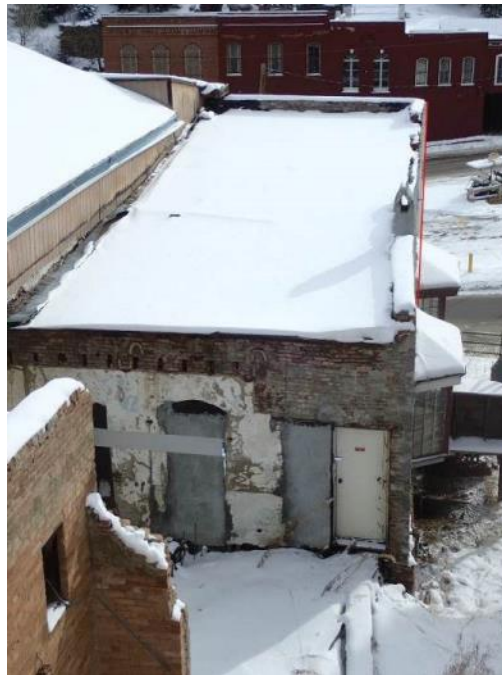
The component brick, mortar, and stone comprising the Shoo Fly walls below the roof line are in fair condition due to moisture infiltration and wall movement. However, the deteriorating wood plate at the base of these walls is causing the walls to lean to the north (*Re: Figure 65 & Figure 66*). The north, now interior, wall has leaned most appreciably. The other walls are in poor structural condition with numerous flexural cracks in the south and east walls (*Re: Figure 67*). These leaning walls are braced by the wood floor and roof structure. Note that no modifications to the floors and roof should be performed unless the leaning walls are braced. The west wall leans to the east approximately 4 inches.

*Figure 65: The south wall of the Shoo Fly is leaning north as evidenced by the bowing in the wall. See the red reference line on the image*

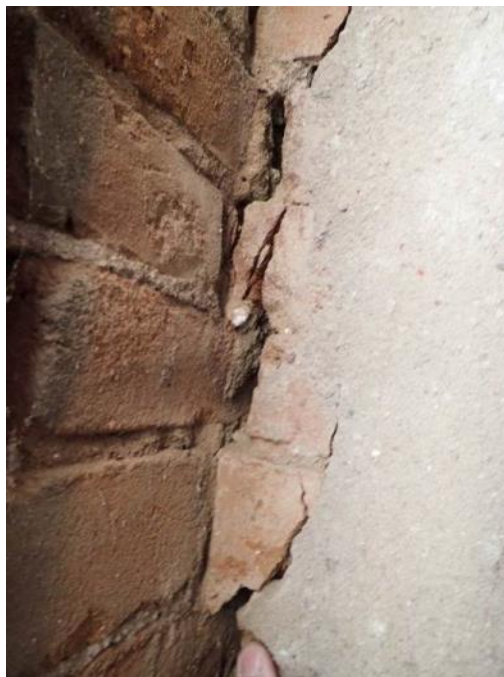
*Figure 71: Closer image of the sheared bricks as explained in Figure 70*

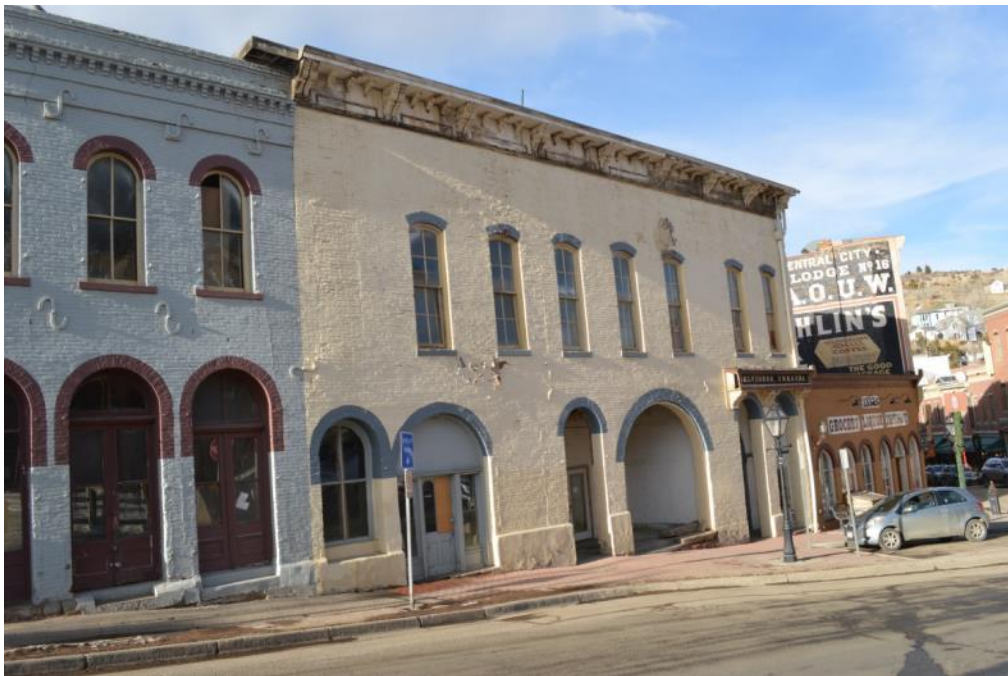
*Figure 72: Overall view of east elevation of the theatre section of the building. Note the wood cornice along the top of the building.*

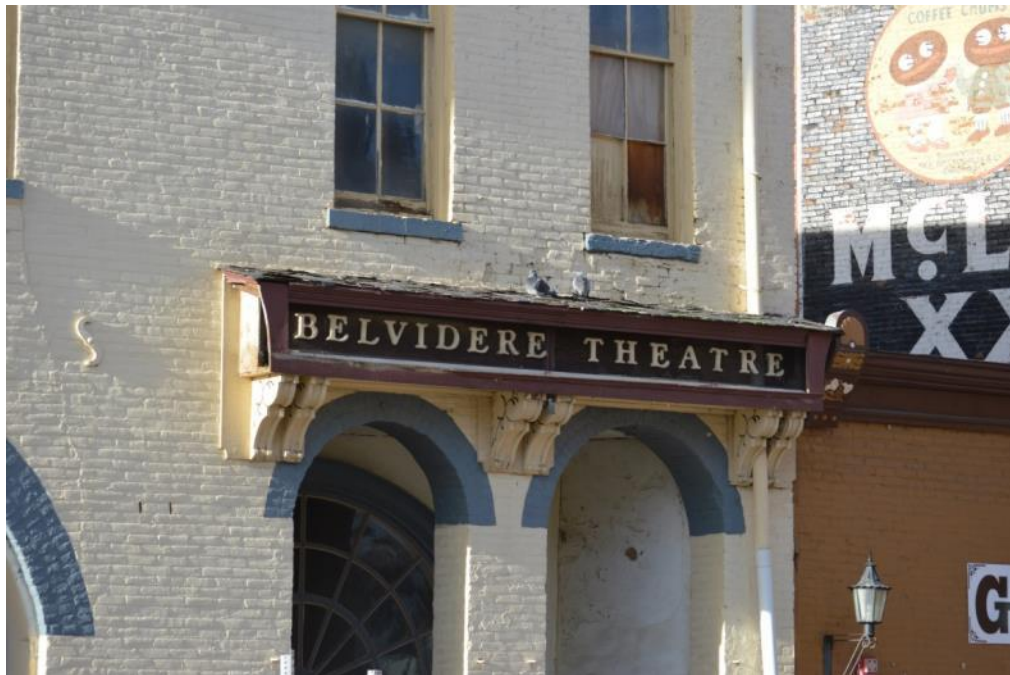
*Figure 75: Detail view of cornice above the north entry on the east elevation.*

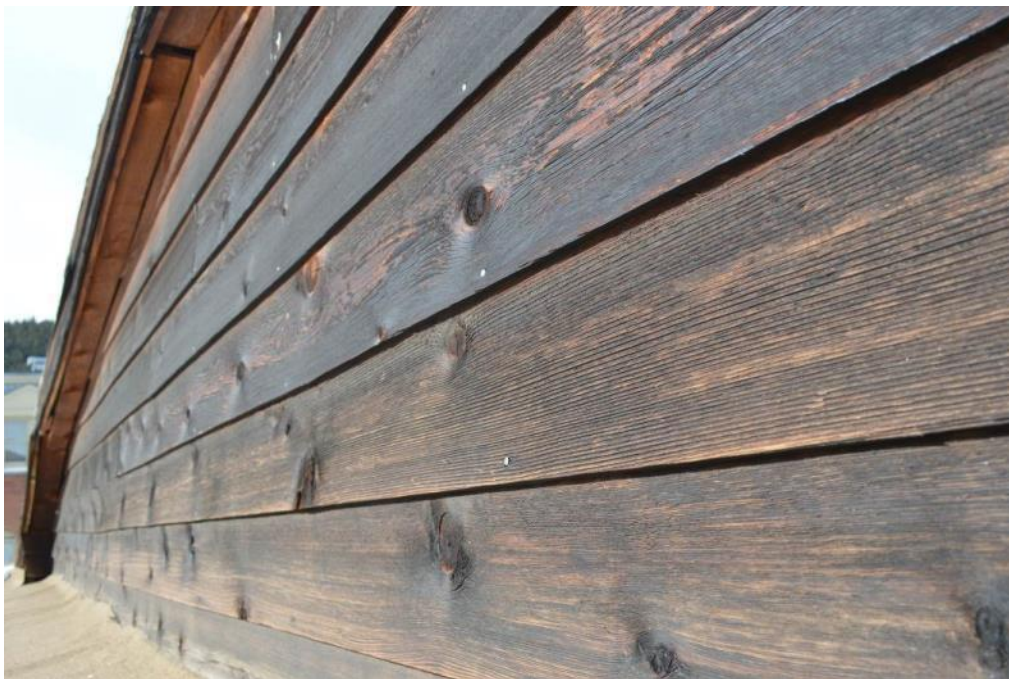
*Figure 76: Wood siding on the upper east elevation of the theatre.*

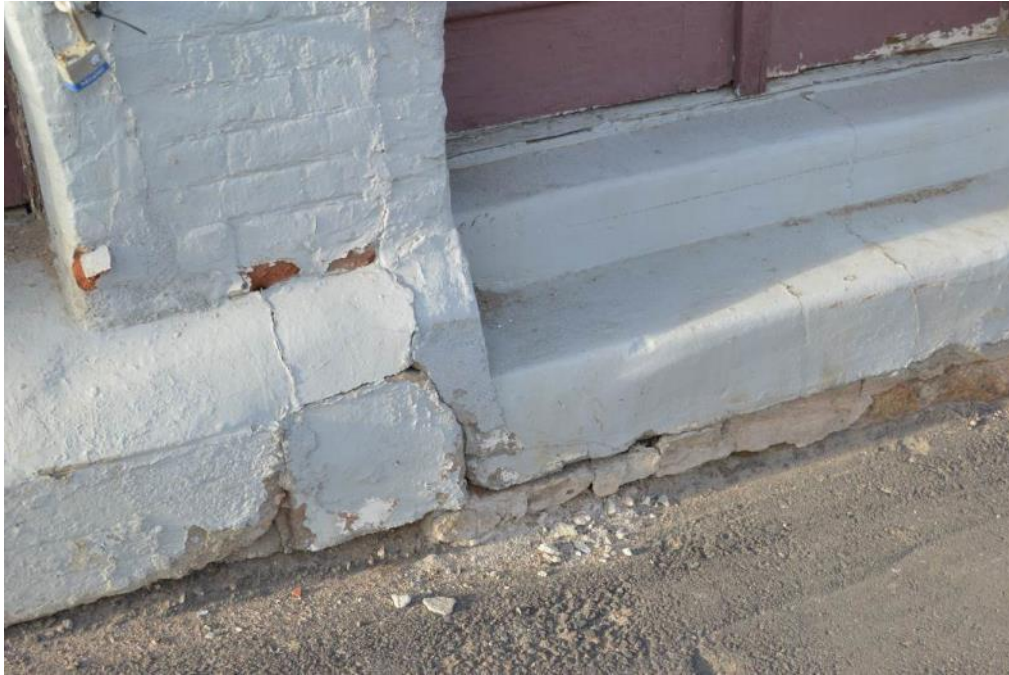
*Figure 77: Parge coat on the lower section of the east elevation.*

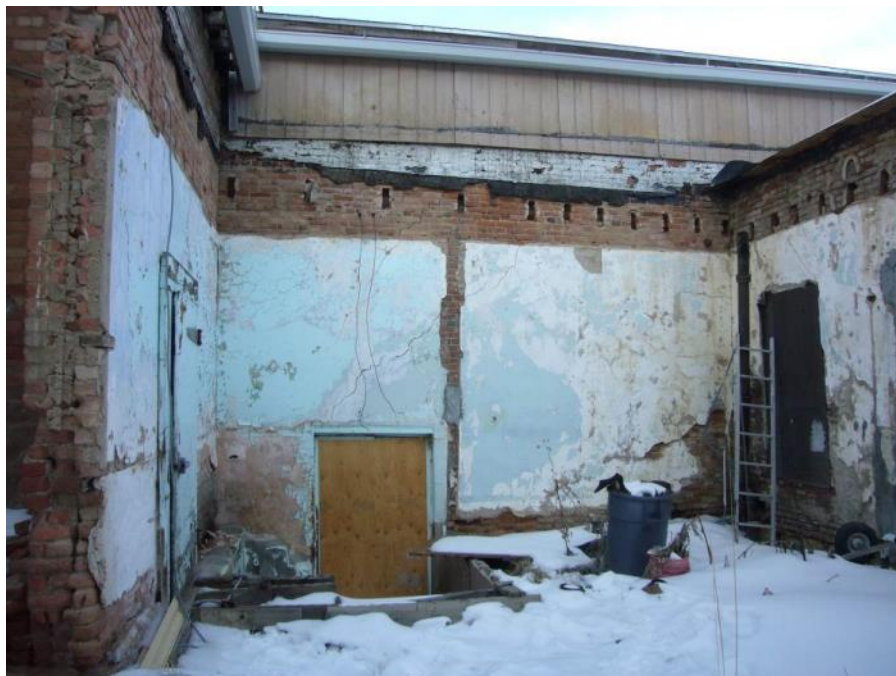
*Figure 78: Plaster walls where the kitchen was removed.*

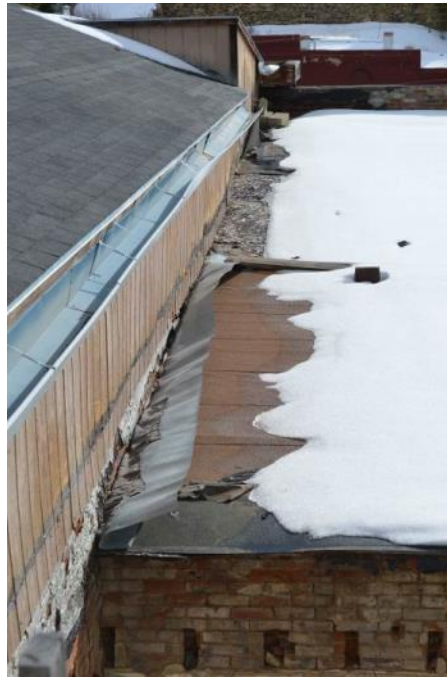
*Figure 79: Vertical siding along the south elevation of the theatre building.*

- Remove vertical wood siding at the upper section of the south elevation. Rehabilitate the south wall of the theatre building so that the vertical wood siding can be removed. (Serious)

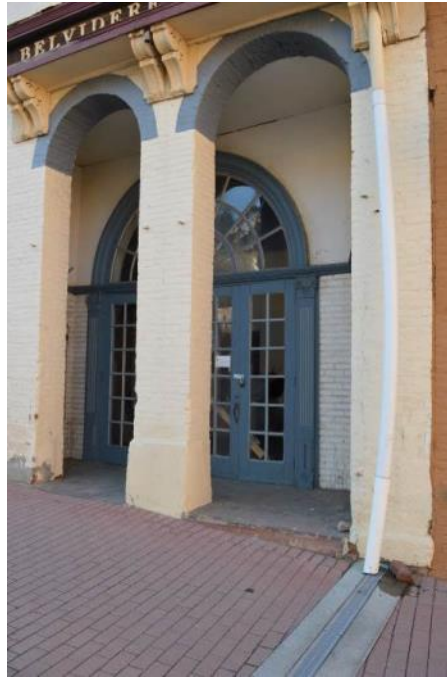
*Figure 85: Overall view of north entrance on the east elevation. Note that the north end of the opening is raised above the adjacent sidewalk.*

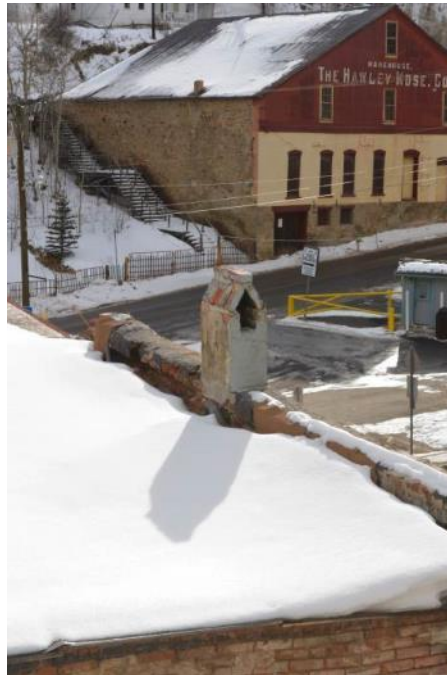
*Figure 91: Chimney along the south elevation of the Shoo Fly.*

- Rehabilitate the chimney on the south elevation of the Shoo Fly. (Serious) Rehabilitation should include:
  - Rehabilitation of brick masonry including repointing, replacement of missing or damaged brick, and resetting of out of plane masonry.

- Rehabilitation of parge coat including repair of cracks, patching missing sections, and prepping, priming, and painting.
